# Technical Service Bulletin

**MULTIPLE ELECTRICAL MALFUNCTIONS AFTER BODY REPAIR**

**Bulletin No.:** 09-035/18

**Last Issued:** 09/14/2018

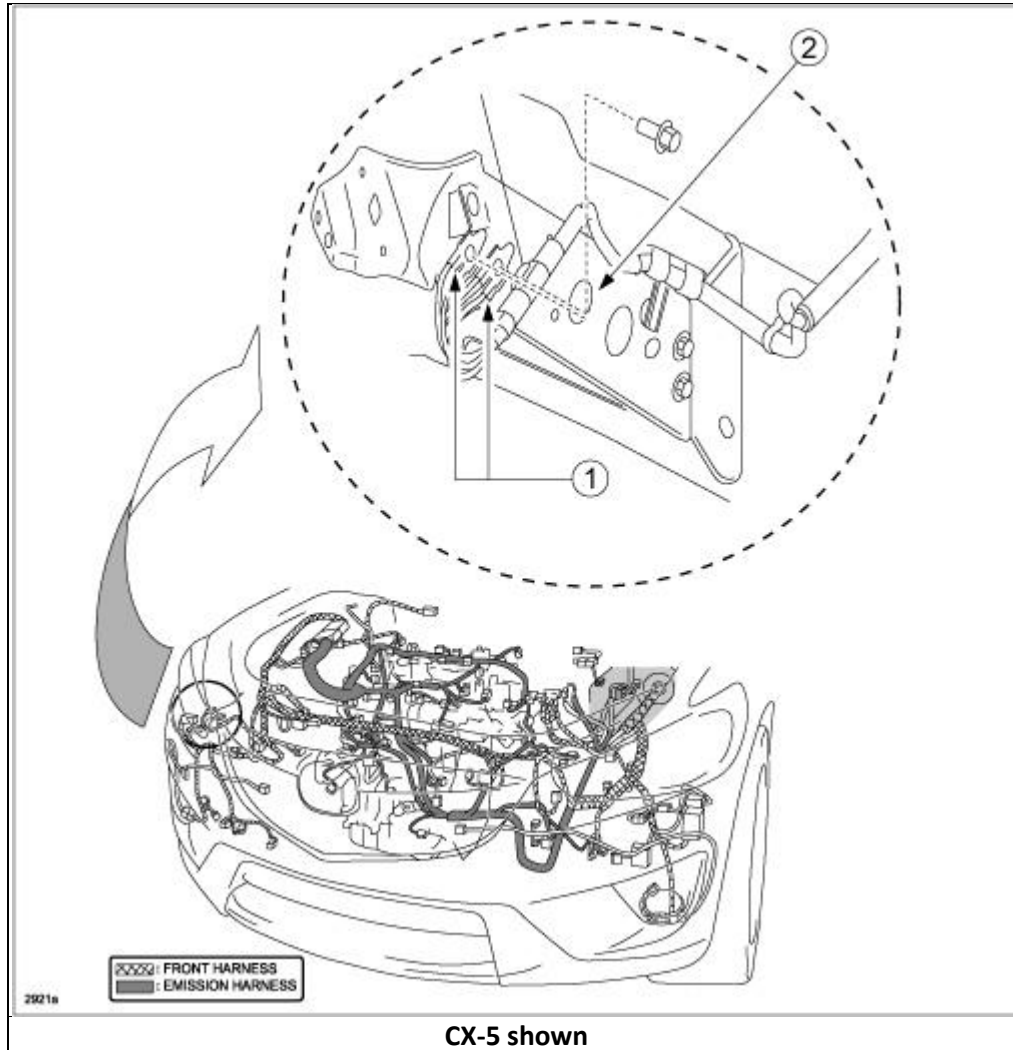
CX-5 shown

Some customers may experience **one or more electrical malfunctions** after a vehicle body repair. The newly painted fender stay (2) may be causing a poor front harness (1) ground connection.

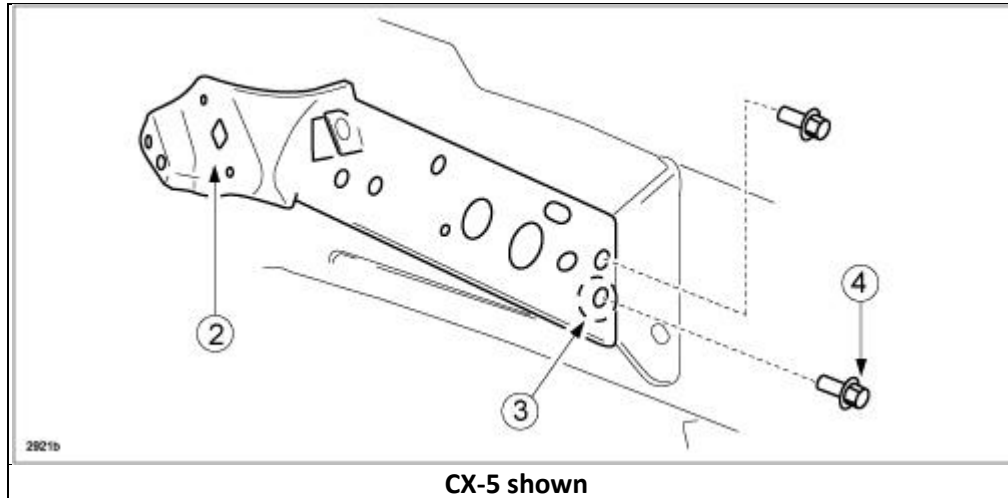
The front fender stay (2) newly painted surface at ground point (3), where attachment bolt (4) is seated, may create a poor front harness ground connection.

**NOTE:** Do not paint ground point (3) where attachment bolt (4) is seated.

Customers concern can be resolved by sanding off paint at ground point (3) where attachment bolt (4) is seated. After installing the bolt (4), apply touch-up paint to the exposed base material area of the front fender stay.
